### 1. Head Section - Chord D

In both cases Pre-Load and Post-Load inspection the very clear, mirror like signal, with sharp and very few facets shape indicates Luck of Side Wall Fusin (LOSWF) in the weld inspected.

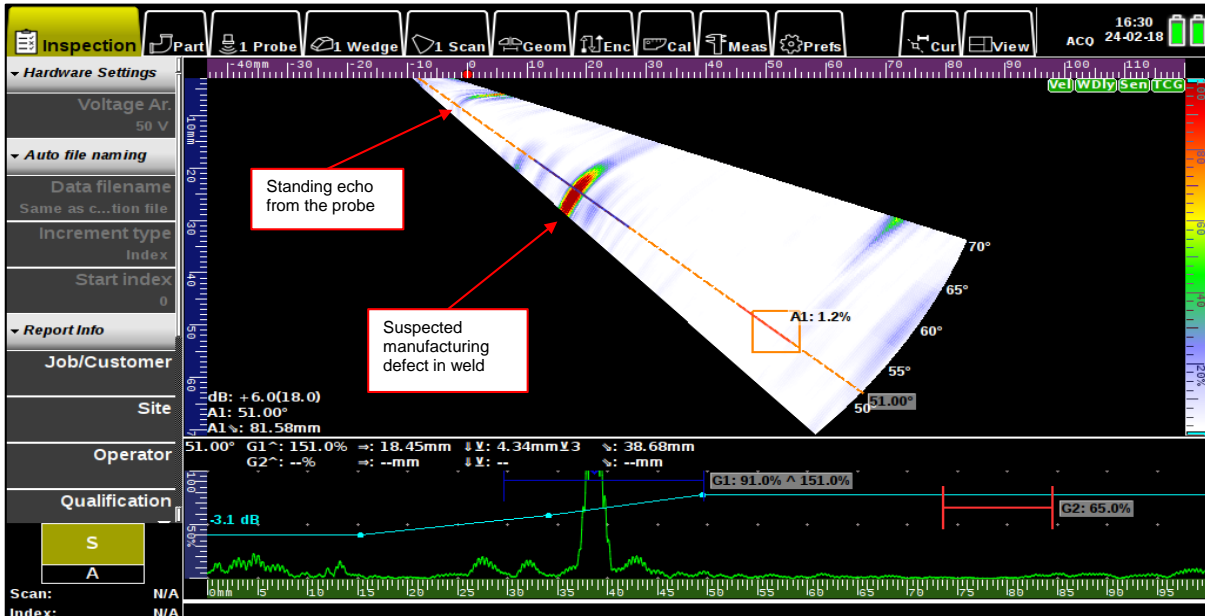
Screenshot of a composite sectorial scan S-scan (Sectorial Scan 45°-70°) and A-scan of a single angular component. The cursor marking 51° identifies the angular location of the defect on the displayed A-scan where the highest amplitude of 151% was noted, significantly breaking TCG (Time Corrected Gain). Very clear, mirror like signal, with sharp and very few facets shape indicates Luck of Side Wall Fusin defect (LOSWF).

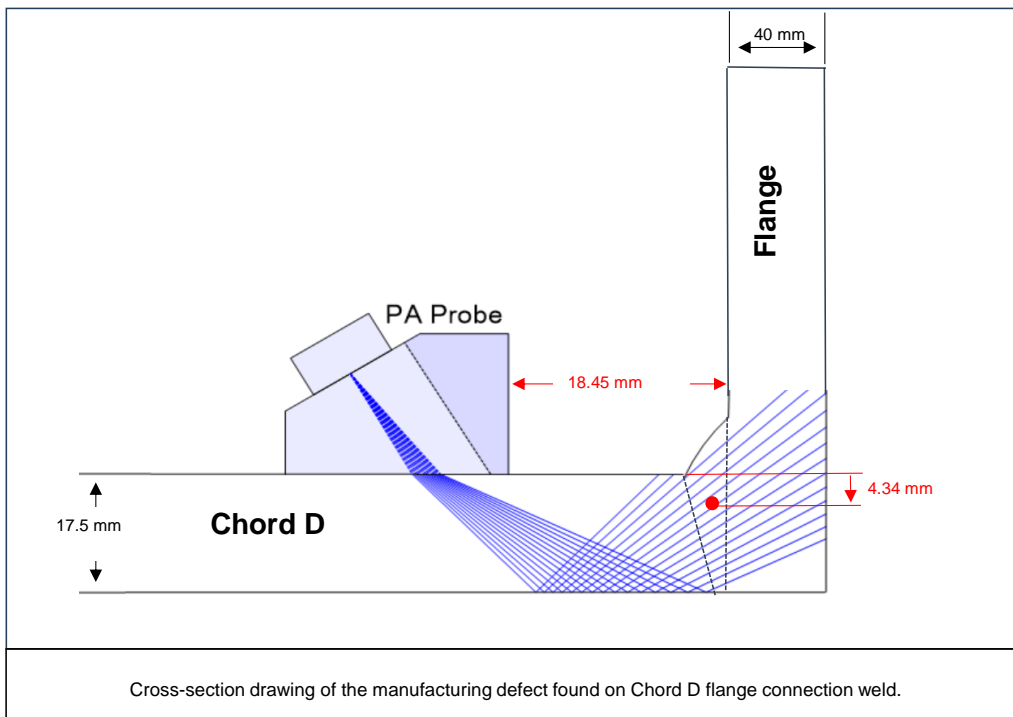
- Post-Load:**
- Angle: 57°
  - Distance from the probe: 22.66mm
  - Depth of the Defect: 13.01mm
  - Amplitude: 200%

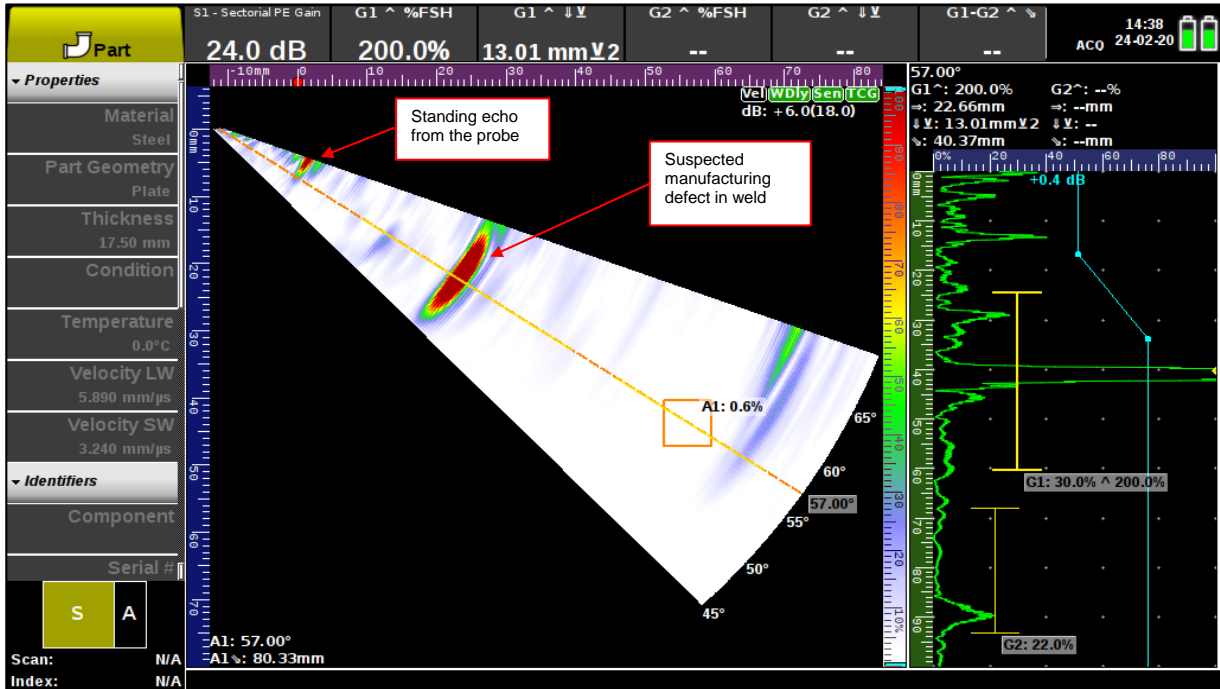
Screenshot of a composite sectorial scan S-scan (Sectorial Scan 45°-70°) and A-scan of a single angular component. The cursor marking 57 degrees identifies the angular location on the defect of the displayed A-scan where the highest amplitude was of 200% was noted, significantly breaking TCG (Time Corrected Gain). Very clear, mirror like signal, with sharp and very few facets shape indicates Luck of Side Wall Fusion defect (LOSWF).

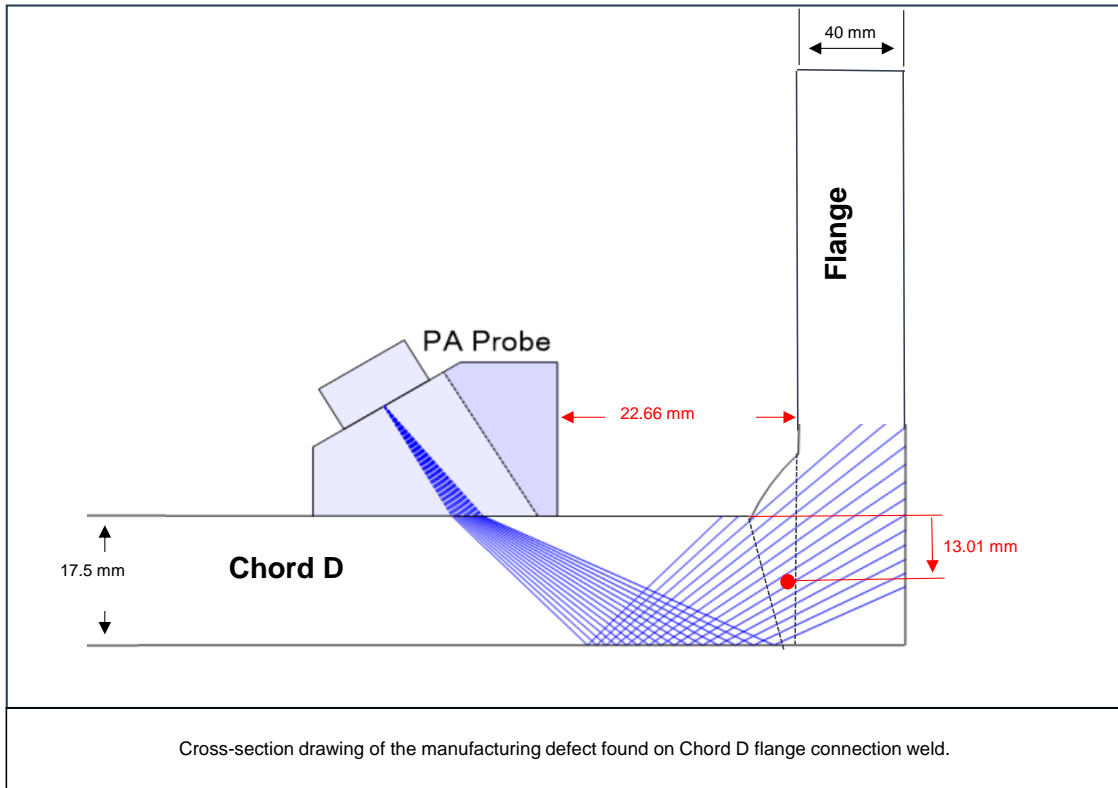
The discrepancy in the depth measurements of a defect identified during Phased Array Ultrasonic Testing (PAUT) over a length of 255mm, with depths of 4.34mm at one point and 13.01mm at another, highlights the non-uniform nature of the defect through the material, specifically in the context of a **lack of side wall fusion in a weld**.

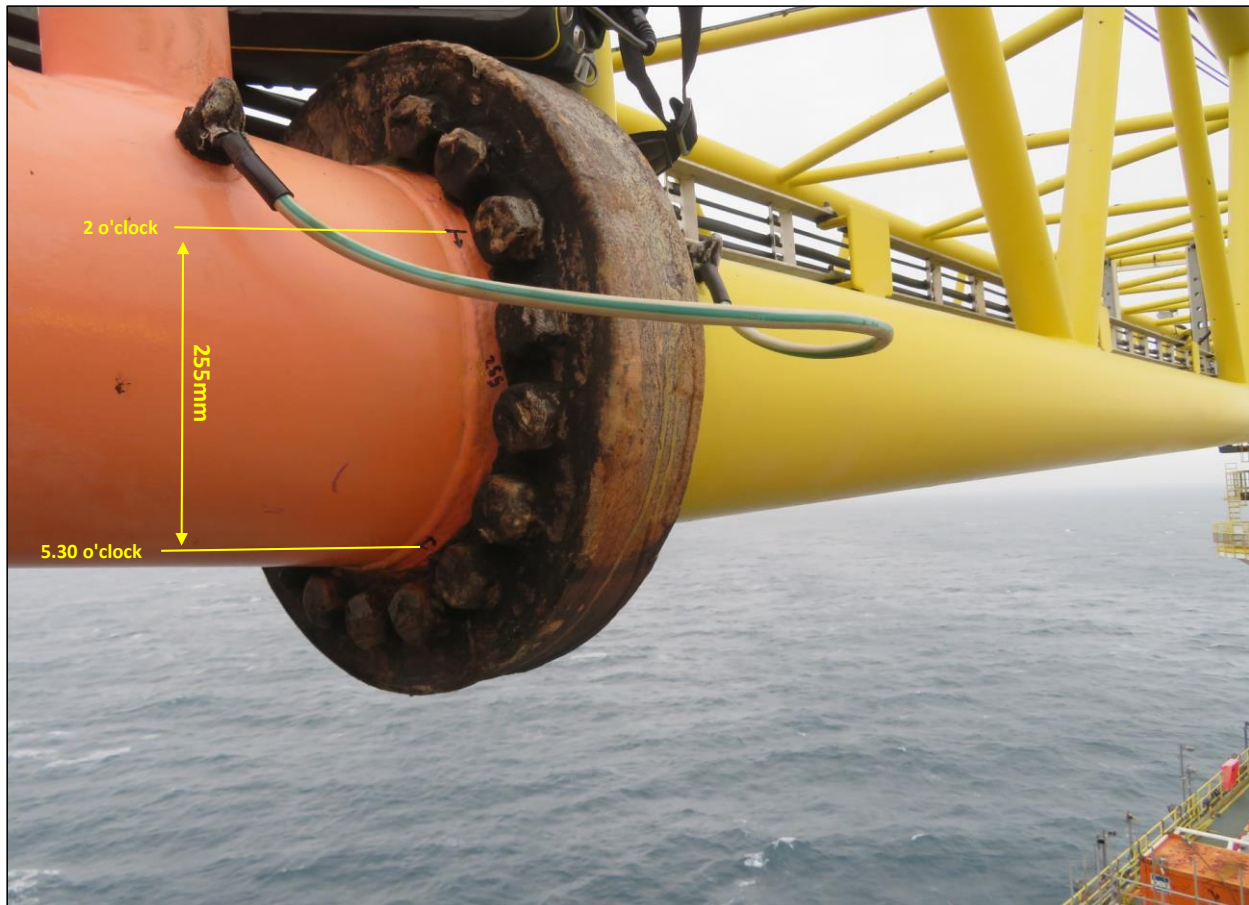
Photo shows location of the manufacturing defect found on Chord D flange connection weld measuring 255mm.

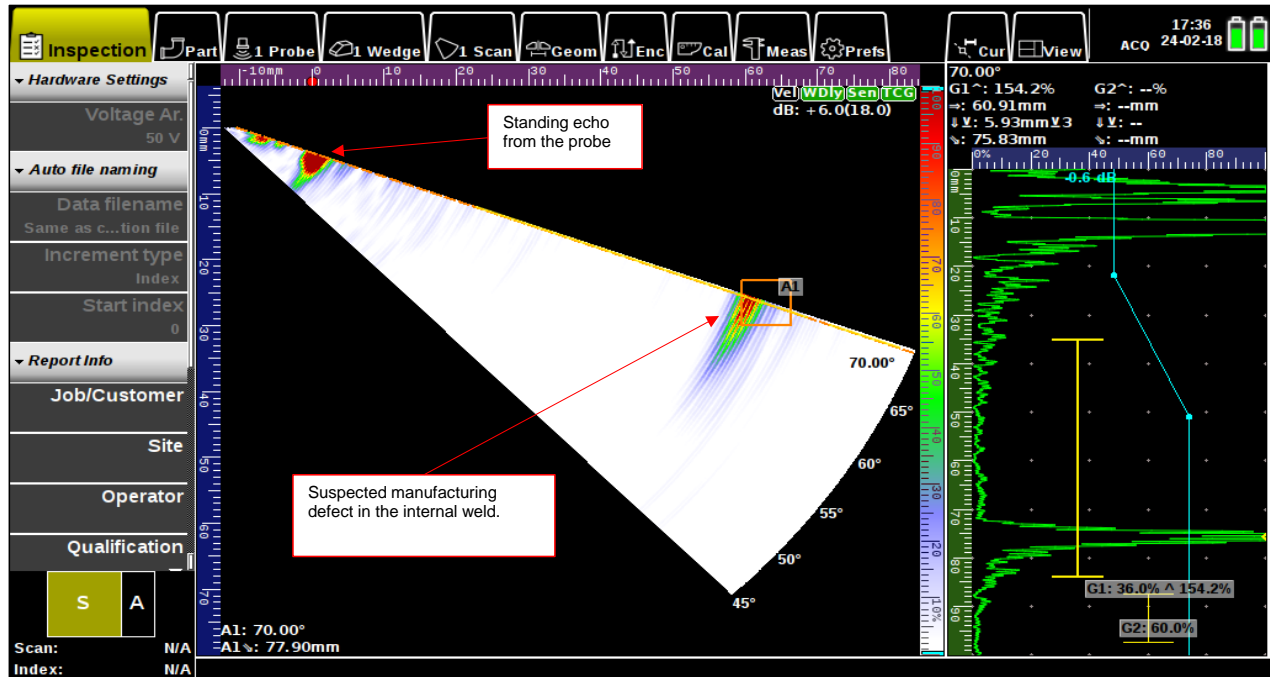
Screenshot of a composite sectorial scan S-scan (Sectorial Scan 45°-70°) and A-scan of a single angular component. The cursor marking 70° identifies the angular location of the defect on the displayed A-scan where the highest amplitude of 154.2% was noted, significantly breaking TCG (Time Corrected Gain). The multi faceted diffusal signal, with defect showing volume (volumetric) indicates Slag Inclusion between weld run.

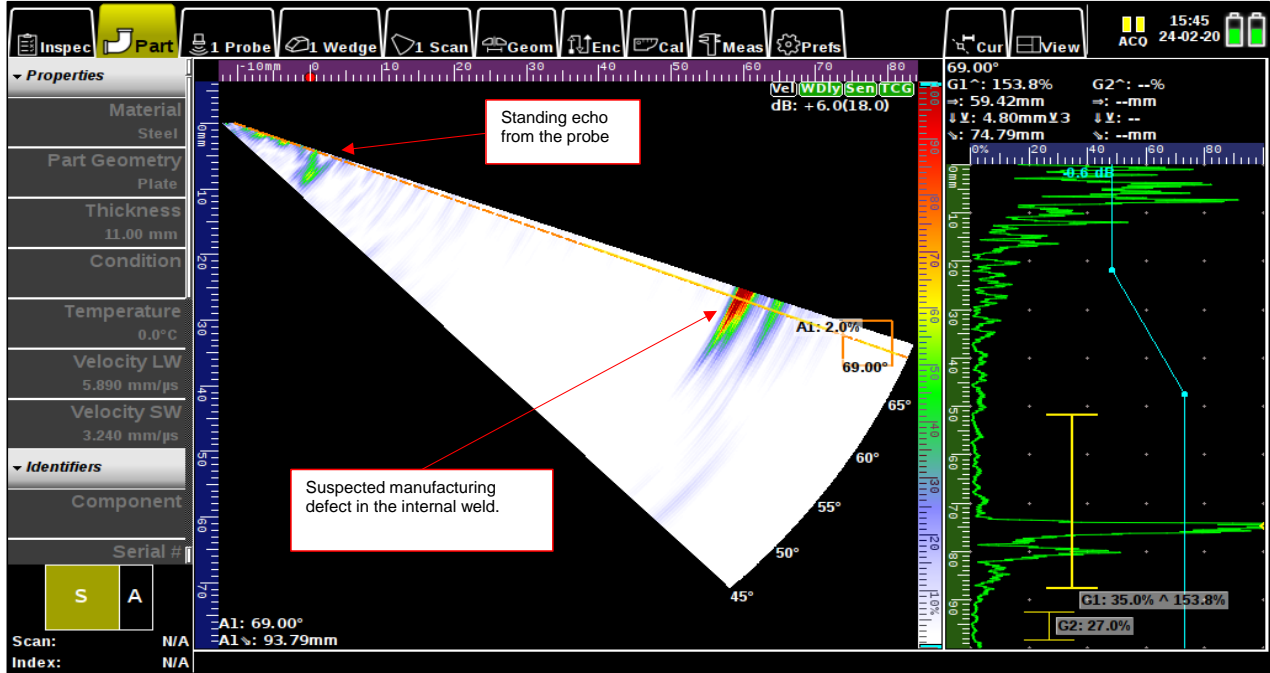
Screenshot of a composite sectorial scan S-scan (Sectorial Scan 45°-70°) and A-scan of a single angular component. The cursor marking 69° identifies the angular location of the defect on the displayed A-scan where the highest amplitude of 153.8% was noted, significantly breaking TCG (Time Corrected Gain). The multi faceted diffusal signal, with defect showing volume (volumetric) indicates

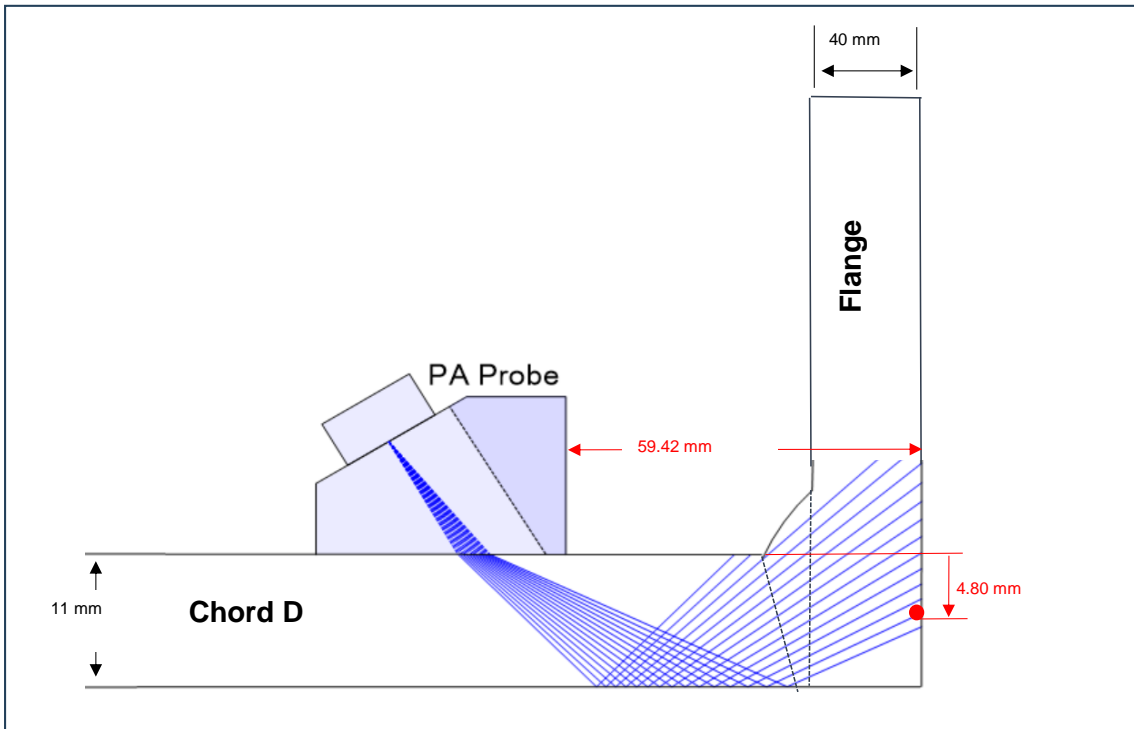
Cross-section drawing of the manufacturing defect found on Chord D flange connection weld.

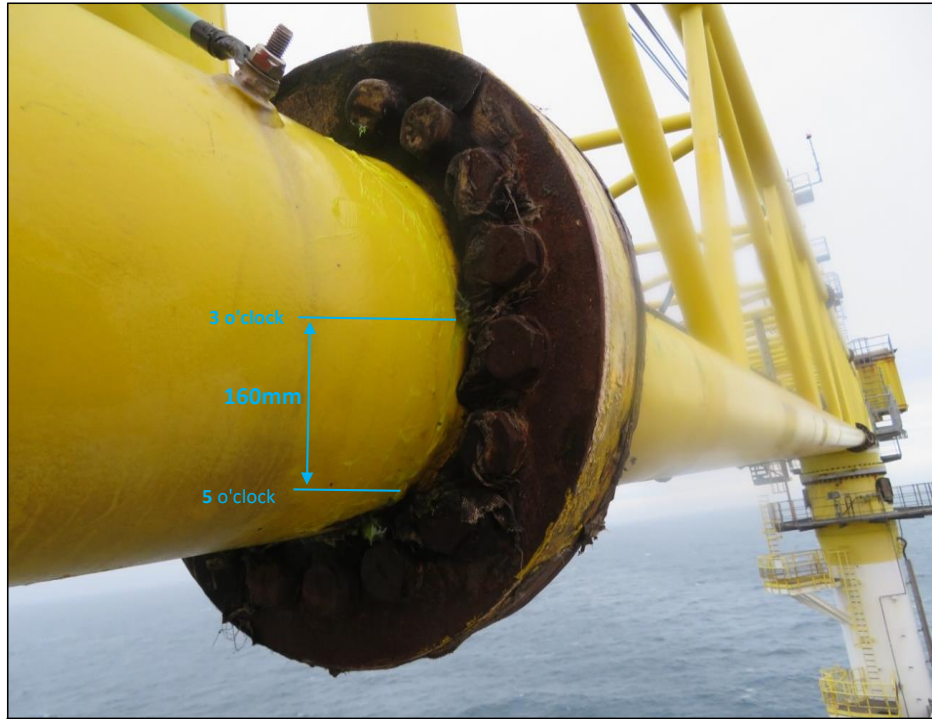
Photo shows location of the manufacturing defect found on Chord D flange connection weld measuring 160mm.
